## Updated Home Inspection Report

**Property:** 999 Johnson Rd.  
Greensburg PA 15601

Bruce R. Thomas 12/12/08 Date	Property: Bill & Mary Seller 999 Johnson Rd. Greensburg PA 15601

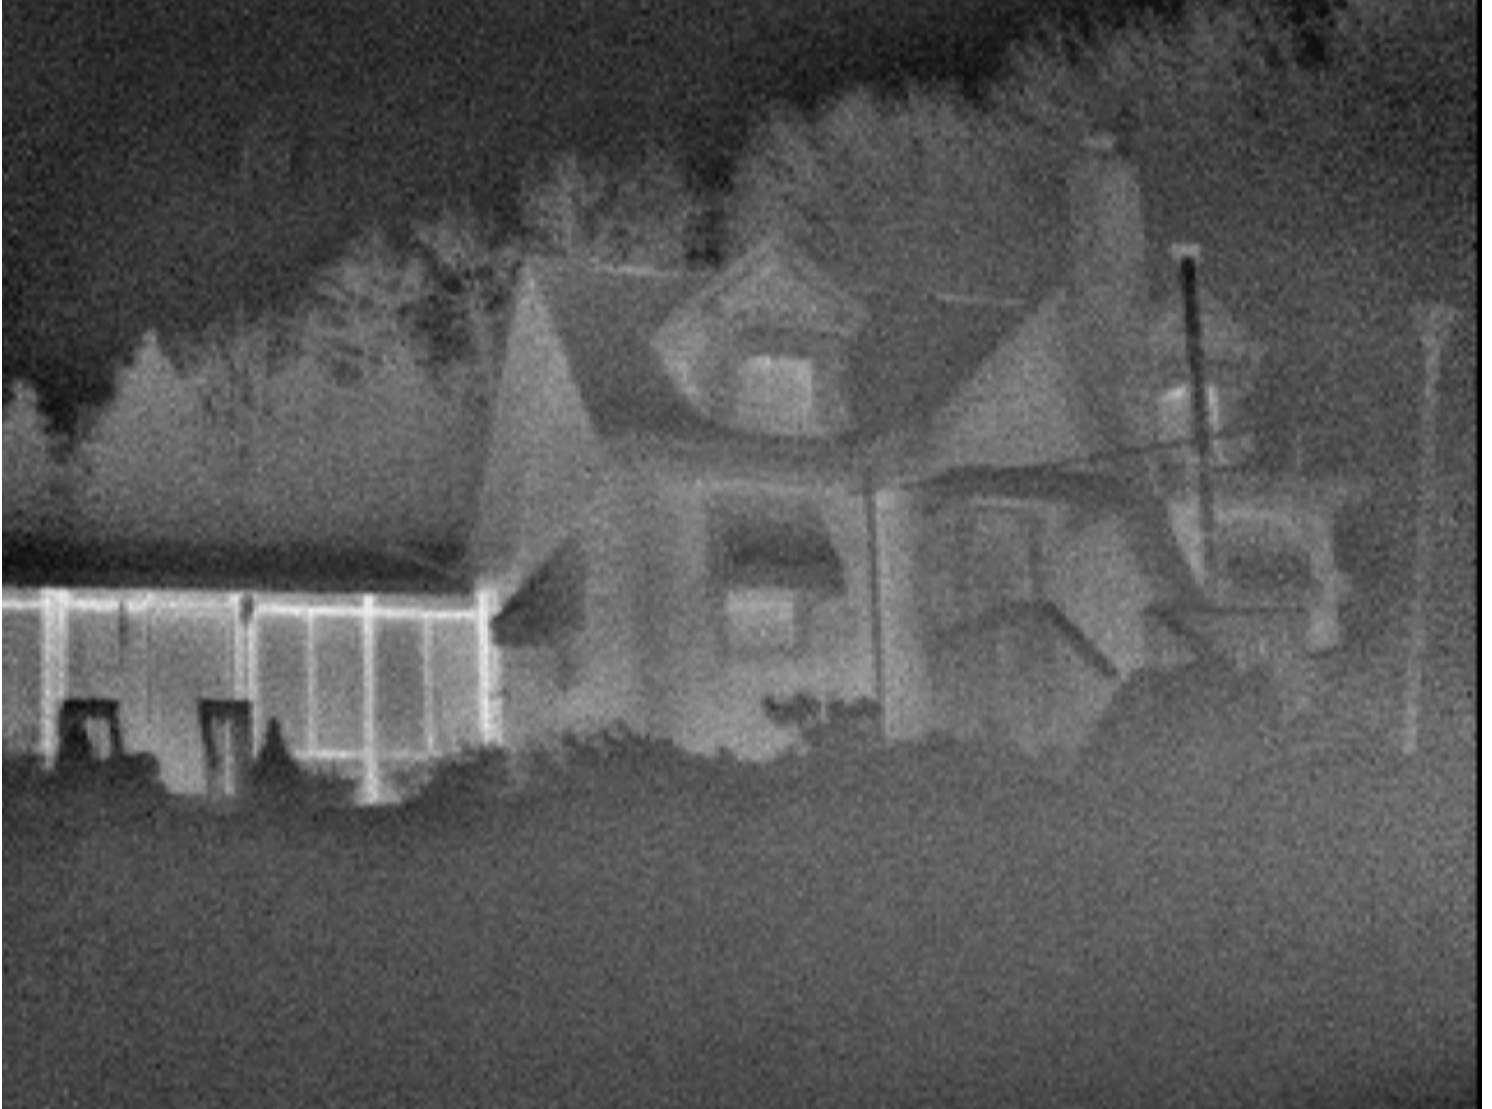
An infrared photo of the home just for reference.
